Manhole Inspection Summary

Manhole # S33A1_002MH

Insp Date: **8/18/08 9:33 AM**

Location Address: **101 w dickman st**

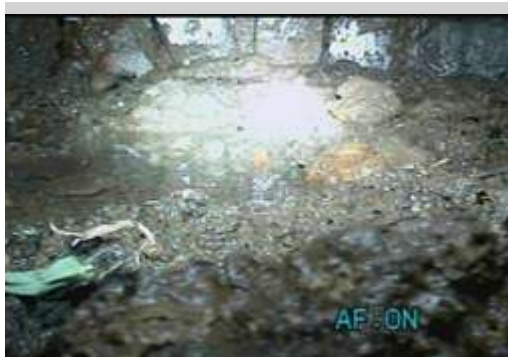
Defect 3

channel debris

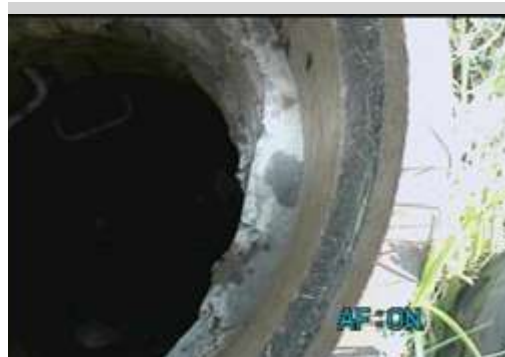
Defect 2

Frame Offset: **2** (in.) Condition: ☒ Sound ☐ Cracked ☐ Leaks

offset

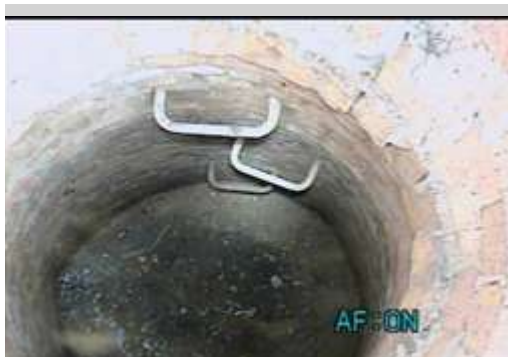
Defect 1

Steps Count: **3** Missing: **0** ☒ **Corroded**

steps

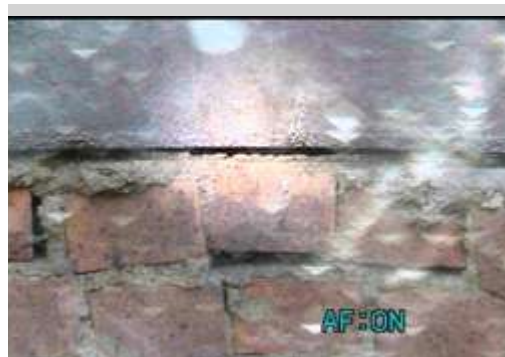
Defect 4

Chimney / Frame Adjustment ☒ Exists Material: **Brick and Concrete** ☐ Parged Height: **11** (in.)

Condition: ☐ Sound ☐ Cracked ☐ Root Intrusion ☐ Loose Brick ☒ **Deteriorated**

frame adj

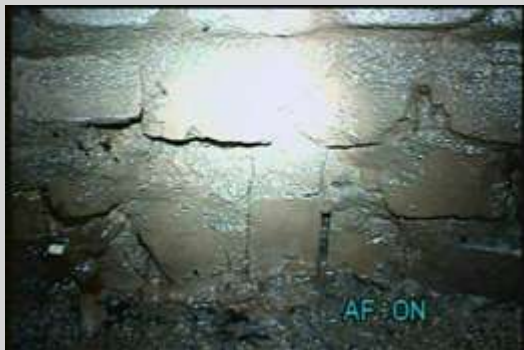
12 O'Clock Outflow

pipe is at the bottom of screen

Deposits: ☐ None ☒ **Mud** ☐ Sludge ☒ **Debris** ☐ Grease

Silt Depth: 8 (in.) Deposits Extent: **Heavy**
